INVESTIGATION OF TEMPERATURES ATTAINED BY PLASTIC FUEL GAS PIPE INSIDE SERVICE RISERS

TR-30

APPENDIX A
2017 - 2018 TEST DATA
INVESTIGATION OF TEMPERATURES ATTAINED BY
PLASTIC FUEL GAS PIPE INSIDE SERVICE RISERS

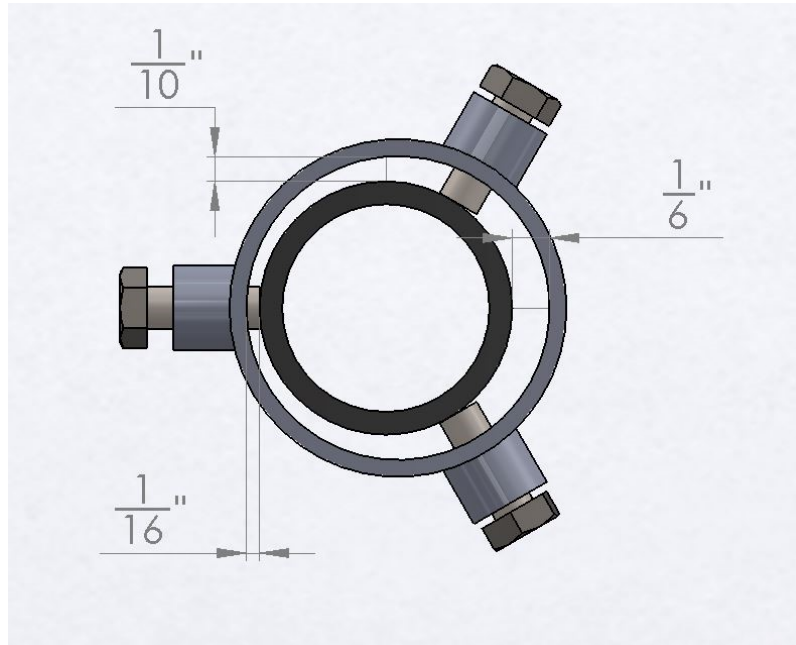
Figure A.1: Cross sectional view of PE tubing in metal casing

2.1. The sixteen (16) assemblies used for this study consisted of 5-foot lengths of 1 CTS polyethylene tubing installed in a 5-foot length of 1-1/2-inch O.D. metal casing made from 0.075-inch wall thickness tubing. The two ends of the metal casing were capped with an access hole in the top cap for the thermal couples to exit the casing assembly. The plastic pipe was secured in the metal pipe by thumbscrews locked in place so the annular space could be maintained at three (3) different air-gaps and the plastic did not touch the metal pipe in four locations evenly spaced around the casing. **Figure A.1** shows a cross section of the metal casing and PE tubing with air-gap spacings of 1/16-inch, 1/10-inch in two places 180° apart, and 1/6-inch. **Figure A.2** shows the test

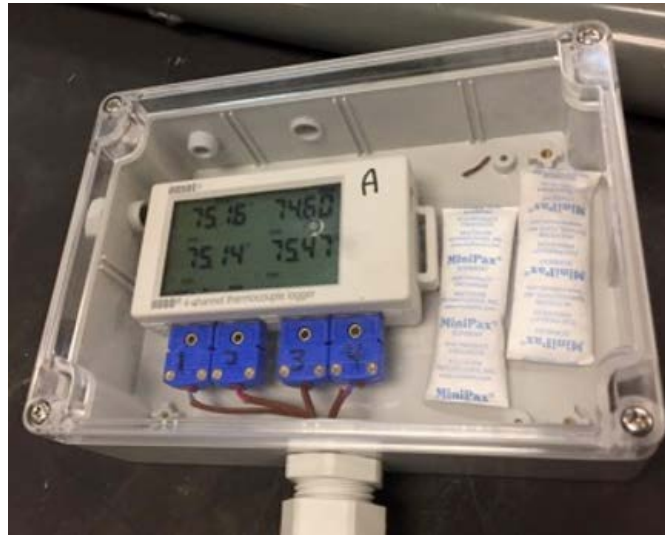
Figure A.3: Data logger housing

- 2.2. Each riser assembly included four (4) thermocouples with the sensing element bored into the mid-wall of the plastic pipe at 12 ½ inches above ground level which is the typical plastic termination point for SWG riser installations. A HOBO UX120 4-Channel Thermocouple Data Loggers was installed at each of the sixteen (16) locations to capture daily temperature data at five-minute increments. Each of the Data Loggers were housed in a protective, weatherproof casing with dimensions of 6.75" x 5" x 2.25" as shown in **Figure A.3**. **Figure A.4** shows an installed data logger with foil wrapped cardboard protective cover to protect against direct sun. Gas service risers installed in a South facing direction at the Henderson, NV test site is shown in **Figure A.5**. A close-up of the West facing riser assembly being installed is shown in **Figure A.6**.

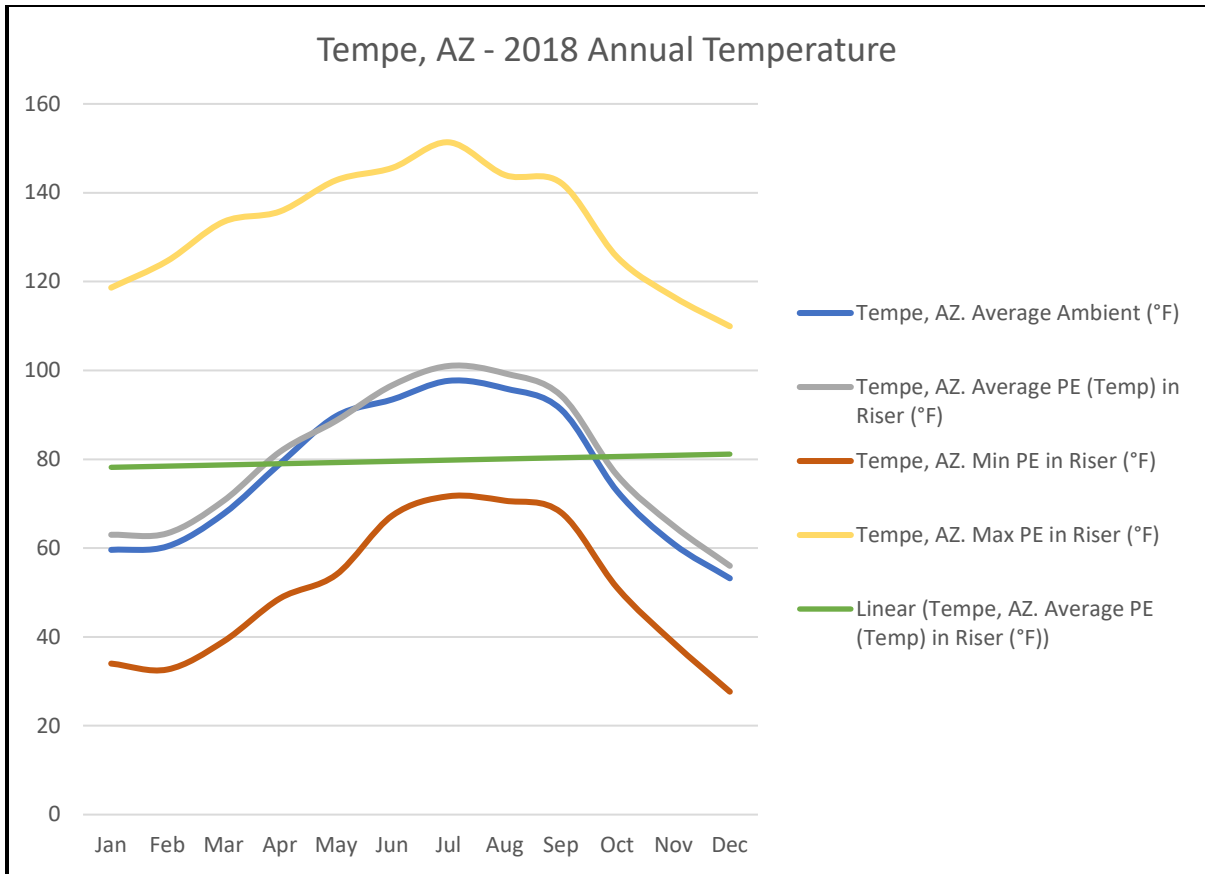
Figure A.12: Tempe annual temperatures by month

4.2.3. The maximum, minimum, and average 2018 annual temperatures by month are illustrated in **Figure A.12**.

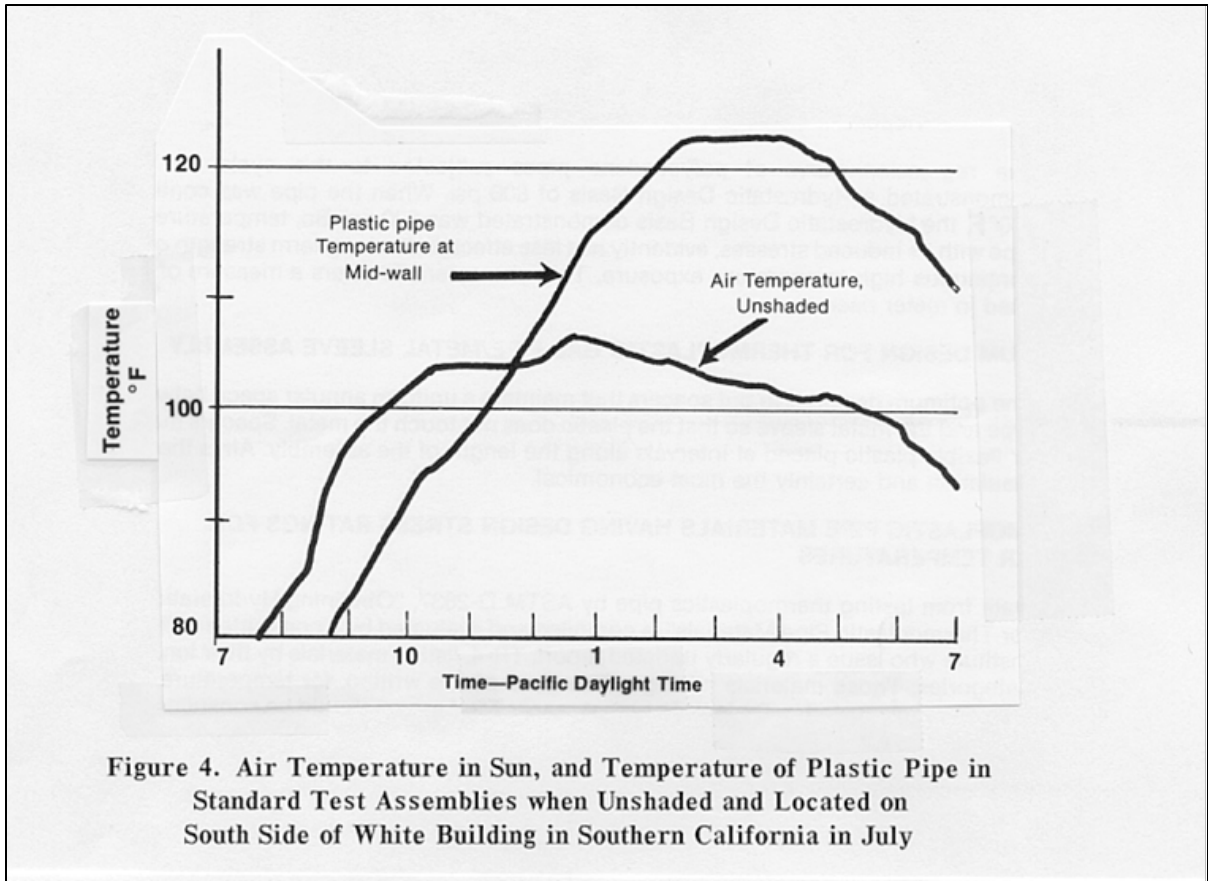
Figure B.3: Typical air vs. pipe temperatures

5.2. A typical air temperature vs. plastic pipe temperature relationship is shown in **Figure B.3**. A number of such relationships were used to arrive at the observations listed in **5.1** above.

Figure 4. Air Temperature in Sun, and Temperature of Plastic Pipe in Standard Test Assemblies when Unshaded and Located on South Side of White Building in Southern California in July

5.1. A correlation has been established between the ambient air temperature and the plastic pipe temperature in the simulated meter riser device, placed in stringent summertime environments. The value of this correlation is that it permits estimation of the number of hours the pipe will be above 120°F or above 100°F from a knowledge of the air temperature vs. time plot. Following are several such relationships:

- When the air temperature is between 100°F and 105° F for 7-1/2hours, the temperature of the plastic pipe will be above 120° F for 2-1/2 hours.
- When the air temperature is between 100°F and 102°F for 3 hours, the temperature of the plastic pipe will be above 120°F for 1 hour.
- If the air temperature is less than 100°F, the plastic pipe temperature will not reach 120°F.
- If the air temperature is below 80°F, the plastic pipe temperature will not reach 100°F.
- Air temperatures between 80°F and 99°F will probably cause the plastic pipe temperature to exceed 100°F. The pipe temperature will likely be above 100°F for about one-third of the daylight hours that the air temperature is between 80°F and 99°F.
