HDPE Pipe Brings Life Back to Miami-Dade Water System

Property Protected and Narrow Work Area Problem Solved With Pipe Splitting Technique; Old Water Lines New Again

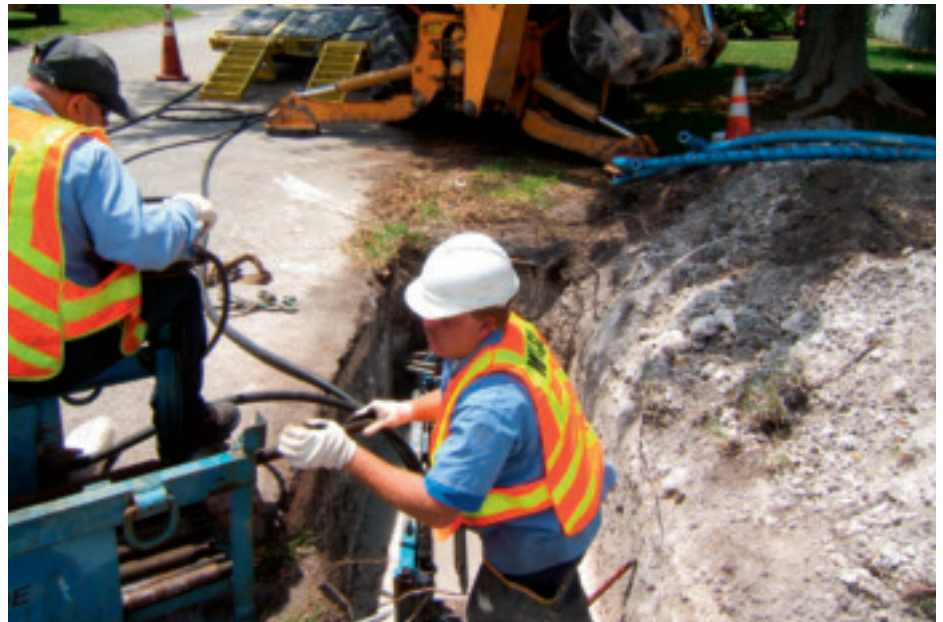
MIAMI, Fla. – Miami-Dade’s two-man crew easily installs a new 2-inch HDPE water pipeline. In just a few hours, residents have water pressure returned to normal.

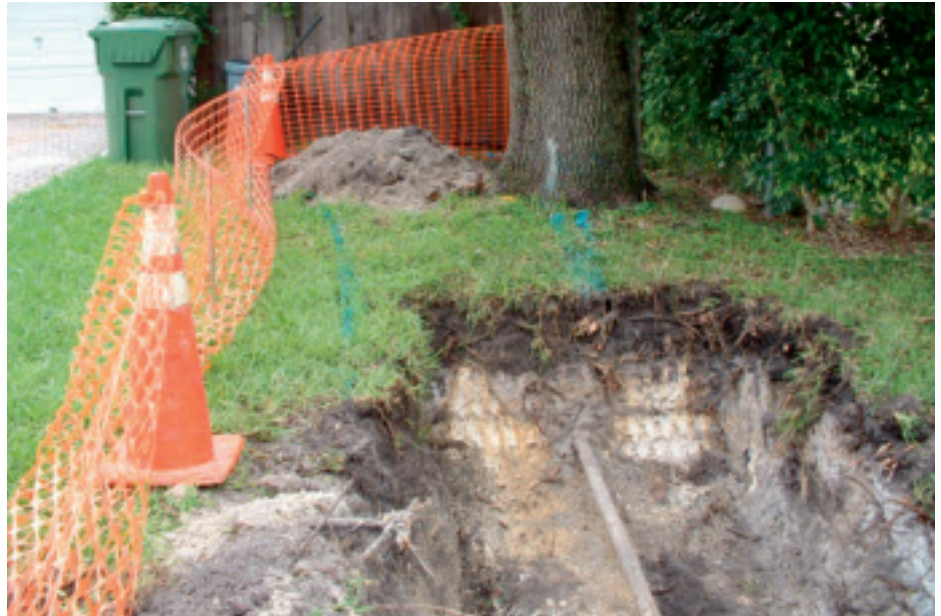
MIAMI, Fla. - The old galvanized metal pipe provides a path for the new HDPE pipe to follow. The Miami-Dade crew excavates a small hole, inserts metal rods to break the old pipe and pulls the new HDPE pipe back through.

Once the area for reclamation is determined, the smallest trench possible is dug and the galvanized pipe cut and split. Rods are inserted and pushed through the old pipe. At the end of the run, HDPE pipe is fed through and

pulled back.

The crew uses a compact, hydraulically operated, static pipe splitting system that can fit in a small trench. It was selected also because it has the power to crack the older galvanized pipe, especially a coupling which doubles the thickness of the walls.

“In the trench, we feed the 1-meter long rods through the old pipe and hook into the cutter with an expanding cone that splits the pipe and knocks down any sharp edges inside the pipe. Then the HDPE pipe is hooked up at the other end and pulled back.”

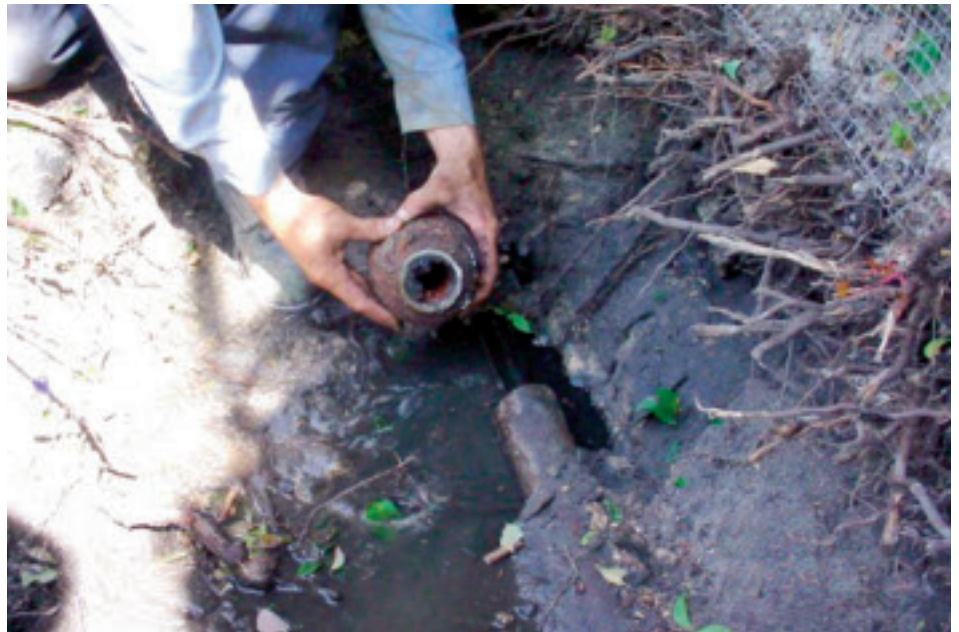
MIAMI, Fla. - Clogged galvanized pipe has restricted water flow to a trickle. Cracks in the pipeline have also reduced water pressure and caused water loss. HDPE pipe, which eliminates this problem of tuberculation, was selected to replace the old line.

With a potable water system just approaching the halfway mark of its projected lifespan, Miami needed to start replacing the two-inch galvanized line in 1999 to address the vast number of leaks in pipe joints and walls, and a system that is constricted due to tuberculation down to the size of a pencil. Completion of the pipe replacement will take at least another 20 years.

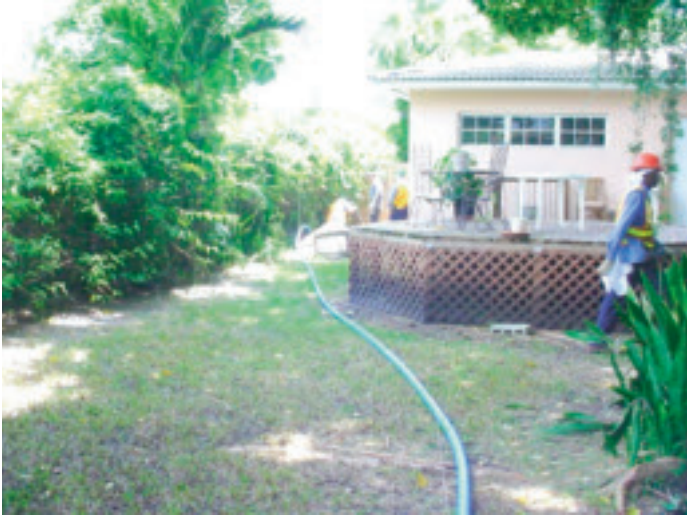
MIAMI, Fla. – A single long-run of 2-inch leak-free HDPE pipe is laid out, ready for installation. But instead of digging up this Miami-Dade Water customer's yard, the pipe will be snaked underground without any property destruction.

According to Frank Lopez, HDPE product manager for HD Supply Waterworks (Thomasville, GA), who works closely with the water department, the pipe was selected because of convenience and performance. “Because the pipe is delivered in 500-foot coils, it’s easier to transport and unroll at the job site. Plus it’s just more economical and flexible to work with.” HD Supply Waterworks distributes a complete line of water, sewer, fire protection, and storm drain products.

Kuffer elaborated on the process of this HDPE pipe installation. “The pipe used by Miami-Dade, which they considered the main line at the time it was installed, was originally two-inch diameter. And because it is being replaced by two-inch diameter HDPE pipe in 500 foot coils, it means that even long runs can be one, joint-free continuous piece. And when connections are made to homes, or pipe sections added, these are literally melted together which makes the system leak-free. This seamless, jointless system provides a longtime utility solution.”

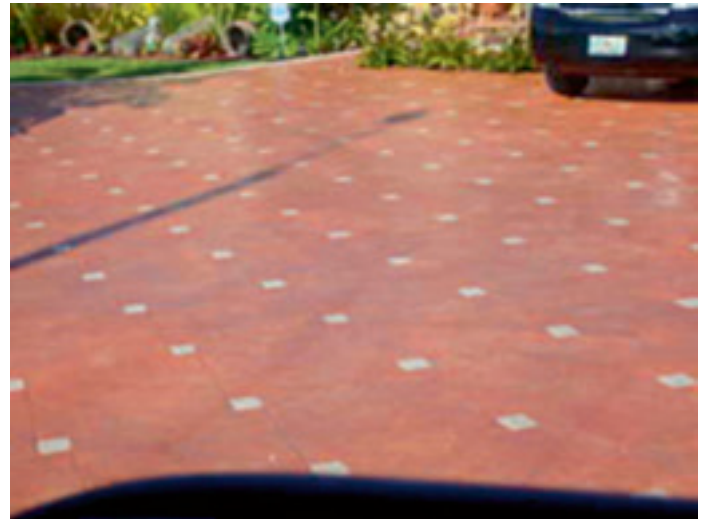
MIAMI, Fla. - Intricately designed, patterned and art-deco driveways are highly prized by Miami-Dade homeowners. In order to save them, the water department threads the much-needed new 2-inch HDPE water pipe-line under the pavement and yards, which also saved time and labor costs.
